# SQUARE - A System for Quality Assurance when Retrofitting Existing Buildings to Energy Efficient Buildings

**Final report from the Swedish pilot project  
Brogården**

Work Package 6. Application of the QA system in pilot projects

Deliverable D6:1. Report on the results and experiences from pilot project

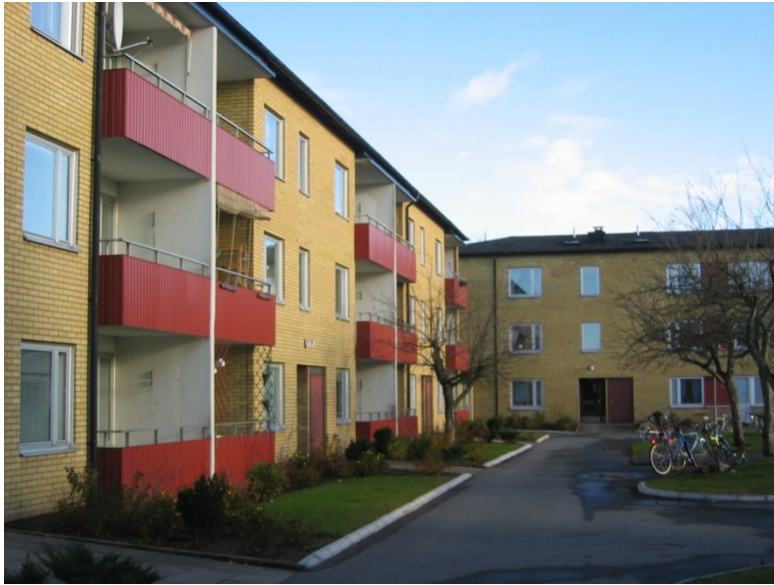
*Figure 1 The Swedish pilot project Brogården before renovation.*

The Swedish pilot project Brogården is a social housing area consisting of 299 apartments of the similar type of construction built between 1971 and 1973, Figure 2. The buildings have problems with frost damages brick facades, draughty apartments, thermal bridges, damaged balcony slabs and moisture damaged concrete ground slabs. The municipal housing association, AB Alingsåshem intends to retrofit the buildings to passive house standard. This will be achieved by supplementary insulation of the building envelope, additional air-tightening the building envelope, changing to super-insulated windows and installing high efficient air-to-air heat recovery. The project is carried out in partner contracting between Alingsåshem (owner), Skanska Housing (contractor), Alingsås Rör (piping), Elteknik (electricity), Bravida (ventilation), Skanska Mark (landscaping) and Sandå måleri (painting) and will go on for five years.

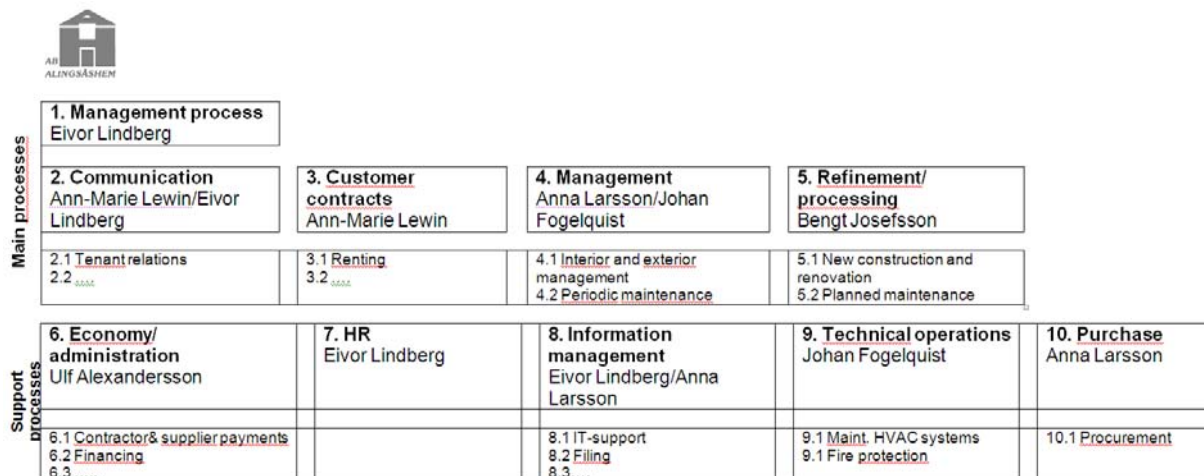
Figure 4 Process structure as shown in the existing QA system of Alingsåshem

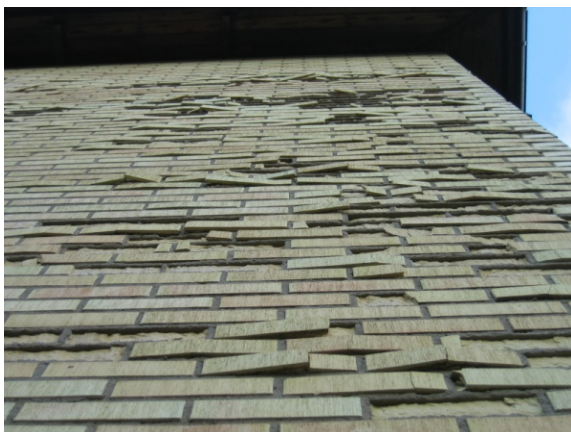
*Figure 6* The brick façade was damaged by frost and had to be torn down.

At an early stage, a first thorough inspection was made to localize shortcomings in the building and problems with the indoor environment. The investigation showed that the apartments were draughty, there were moisture problems in the slab on ground floor, the façade was in very bad condition and the balconies acted as cold bridges.

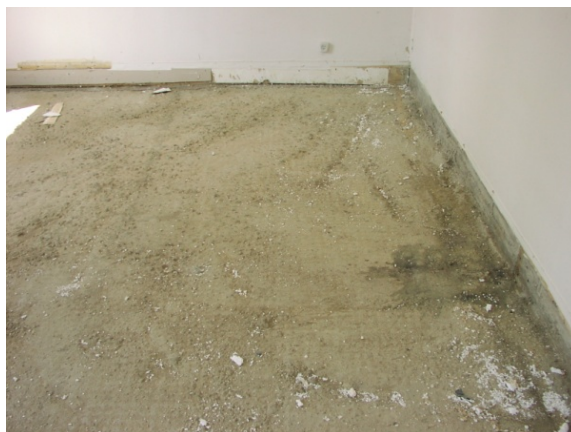
*Figure 7* The ground slab had moisture damages that had to be taken care of.

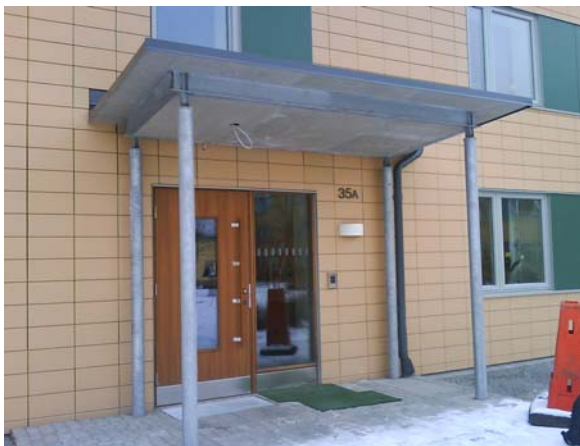
*Figure 8* Appearance of the new entrees.

The entrance halls were made wider, lighter and nicer by moving out the door section to the façade. New doors were chosen with a much better U-value than before.

For preserving the cultural heritage value of the buildings, the vertical coloured passages were kept at balcony fronts and window sections. The eaves were extended to keep the same appearance even with a much thicker façade. The roofs were covered with black felt to keep the same appearance. The façade were kept yellow with vertical colored passages of green.

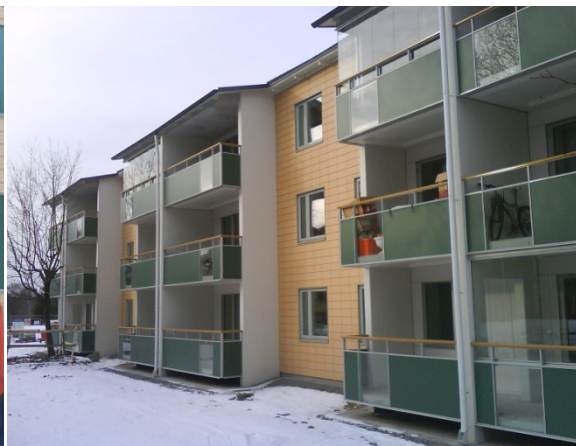
*Figure 9* The vertical colored passages were kept at balcony fronts.

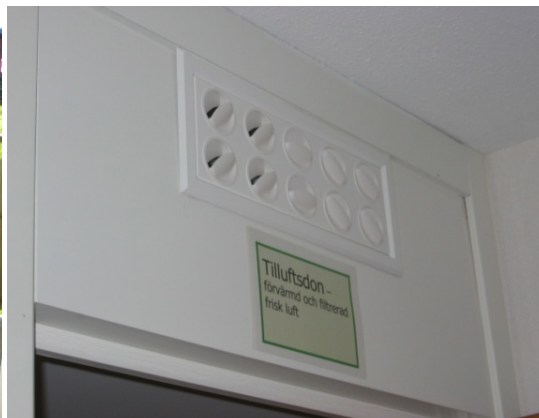
*Figure 19* The sign explains that this is the supply air duct for pre heated and filtrated, fresh air.

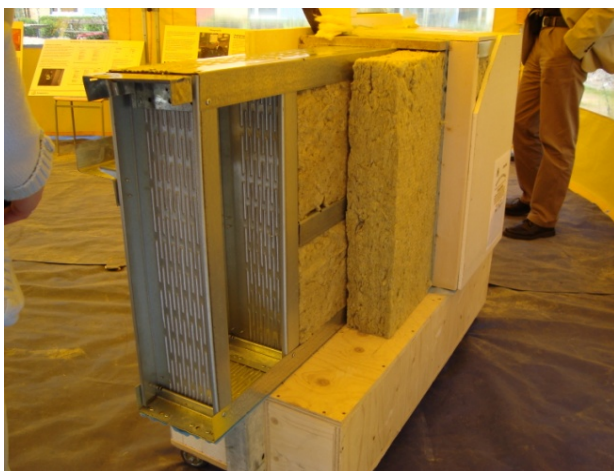
*Figure 20* A prototype of the light in-filled walls was built before building at large scale.

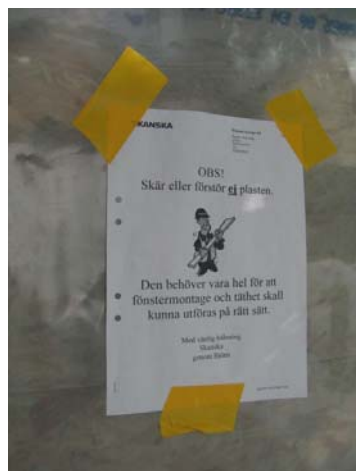
*Figure 21* The workers were reminded of the importance of the air tight layer everywhere.

taped at surfaces around the building site to remind the workers of the importance of the air tight layer, Figure 21.

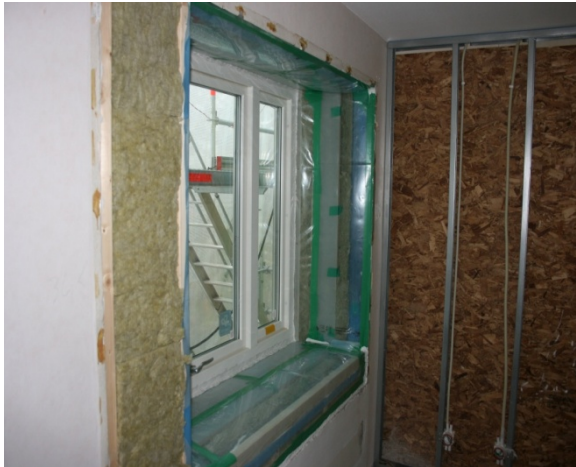
*Figure 22* An example of an air tight solution of a window opening.

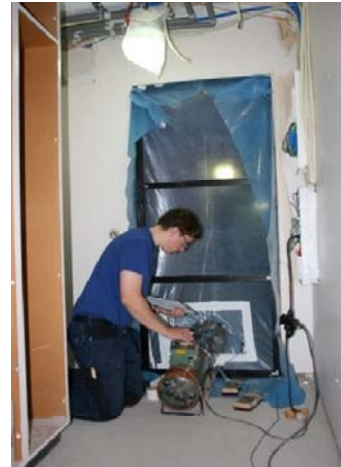
*Figure 23* The air tightness of the building envelope was verified using blower door test.

The function requirements have been followed up in the construction phase. For example, Skanska tested the air tightness of every apartment during construction phase. In October 2008, SP made a blower door test according to EN13829:2000 of one apartment (8077) in the first renovated building to verify the measuring method used by Skanska, Figure 23. The apartment was under renovation and the air tight layer was completed but internal surfaces were not yet finished. The measurements were made at 50 Pa negative pressure. The results from the measured air leakage was 12,4 l/s between apartment and outdoor, 12,7 l/s between apartment and staircase and 12,5 l/s between apartment and staircase at 50 Pa positive pressure. The air leakage measured by Skanska was 12,3 l/s so the agreement was good.

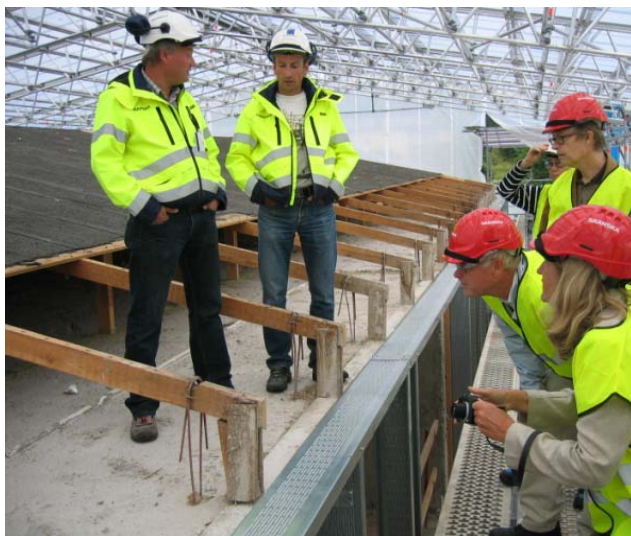
Figure 24 Moisture rounds at the building site.

Measurements of moisture content in the tongued and grooved board in the attic were made during the beginning of the users phase to see that the moisture levels were not critical with respect to mould growth. Predicted drying times has been calculated for the topping concrete casted on the slab on ground. A fast drying mortar has been used in the wet areas. A complete wether protection was erected before demolition to protect the whole building from precipitation. All moisture control measures were documented in the day work sheet.

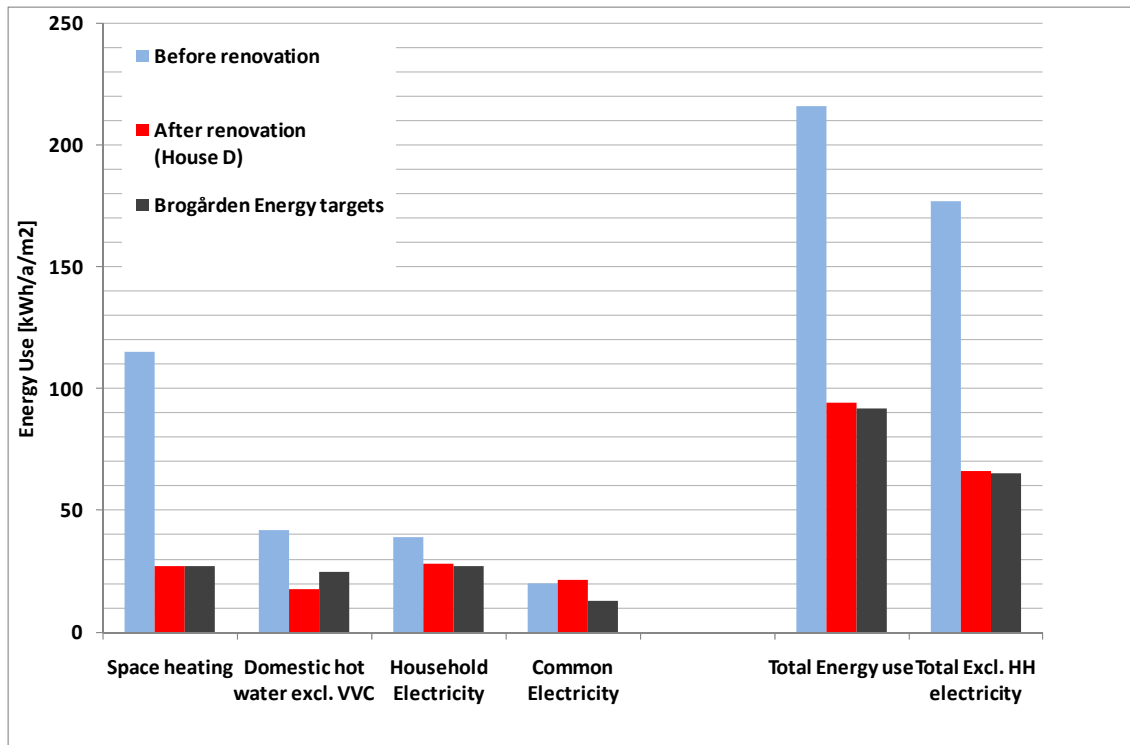
Figure 33 Energy use in house D before and after renovation without any corrections applied.

The figures according to Table 5 after renovation have not been standardized for an average year due to the fact that the existing standard for this procedure is not applicable to houses with extremely low heat demands. Instead, on the basis of calculations taking into account the fact that this winter in western Sweden was 3,5 degrees C colder than average, we have estimated that the heat demand in house D was approximately 40% higher than average. The resulting values are shown in Table 6.

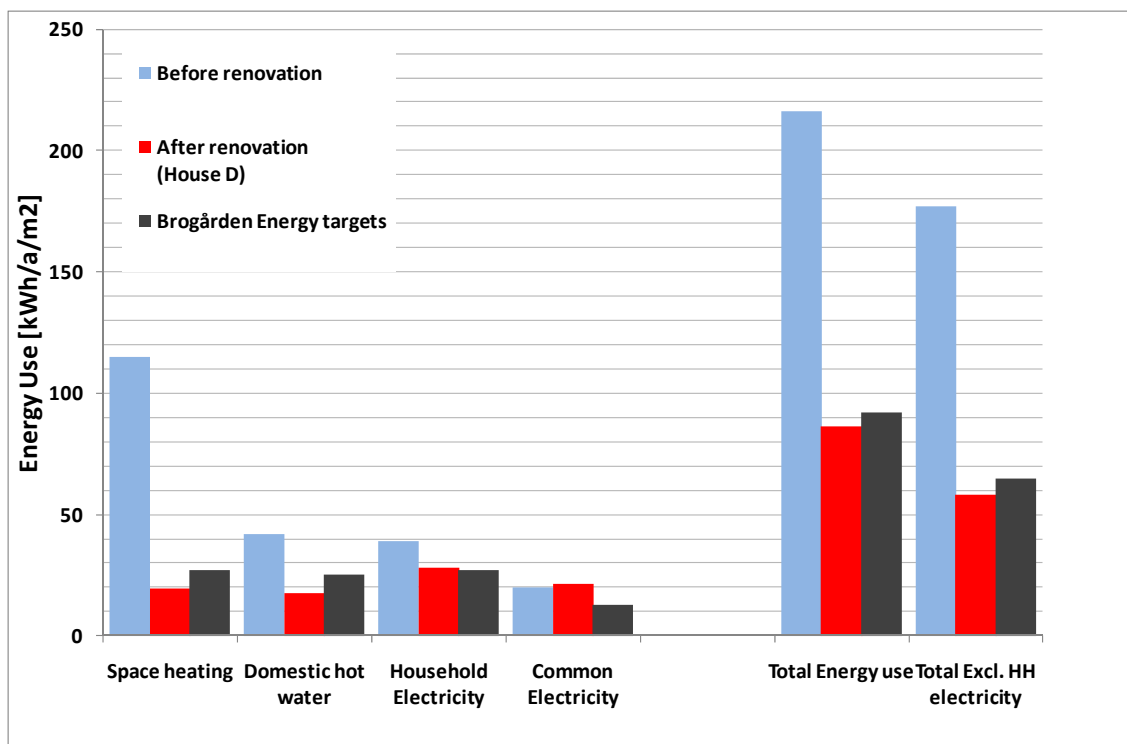
Figure 34 Energy use in house D before and after renovation with corrections applied to the heating demand figures after renovation.

Table 6 Energy use before and after renovation in the first 16 apartments being renovated in Brogården and the targets for the whole project. A correction for the extremely cold winter -09/-10 has been applied to the space heating load which is estimated to be 30% lower than what was measured, in an average year.

The conclusion from these preliminary figures is that the renovation has been extremely successful.

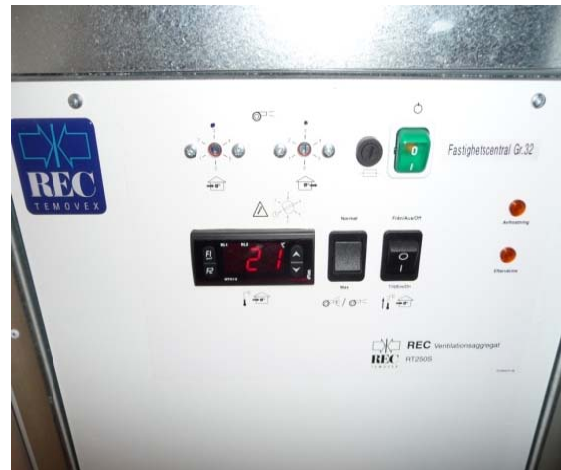
*Figure 38* Air treatment system unit for a single apartment, used in building D.
